January 2015

Report: EP201410210164

Nederlandse Aardolie Maatschappij

**Technical evaluation of Twente water injection wells ROW3,
ROW4, ROW7, ROW9, TUB7 and TUB10
3 years after start of injection**

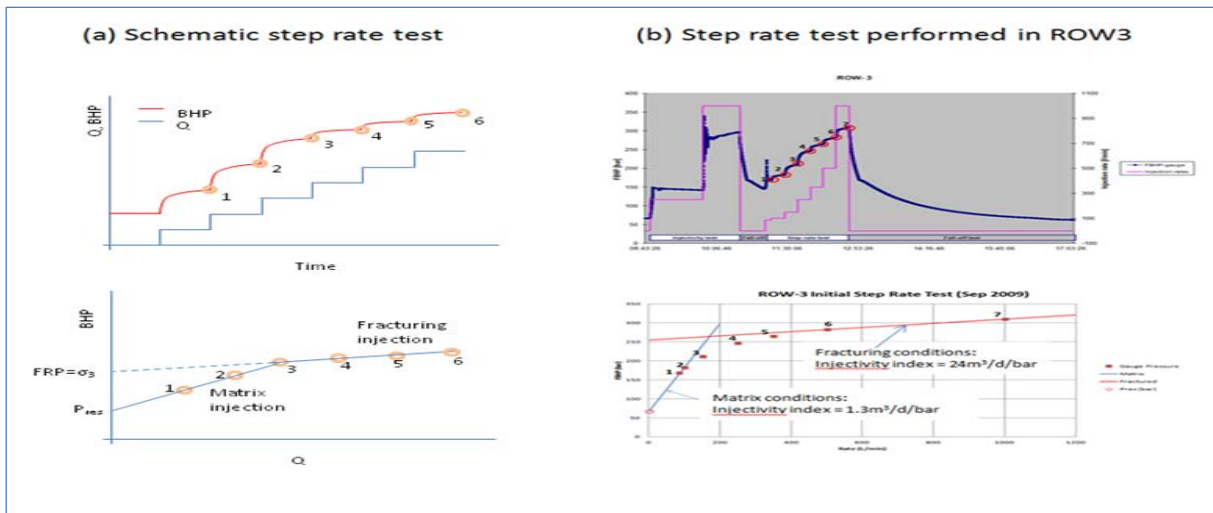
The SRT-data is presented for each well in Attachment 9.3. From the resulting plots, showing the BHP vs. Q , it is obvious from the slope change that formation breakdown occurred only in ROW3 (Attachment 9.3.1). Consequently, the injectivity (expressed in $m^3/d/bar$) increases. For the other wells, where water is injected into the fractured Zechstein Carbonate reservoir, the SRT-plots all show a linear trend. As expected, in most wells only a very low BHP is required to inject the planned water volumes. This is because the local reservoir pressure is very low and because injectivity is in general very good. Note that the curve intersects the y-axis at approximately the reservoir pressure.

Figure 4 – Step-rate test principle applied in well ROW3

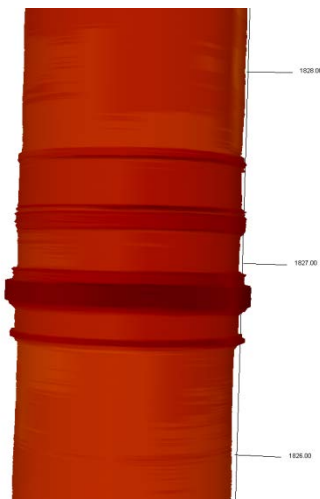
In TUB10 (Attachment 9.6.4) the condition of the production liner underneath the packer was found to be good (maximum pit penetration into the casing is 33% of the original wall thickness). Also the cement bonds across the Carbonate and Halite sections were found to be good. The exception is at 1827 mAHbdf in the ZeZ1T Anhydrite, where a potentially undertorqued casing joint (Figure 7) was observed in combination with a poor cement bond. Considering that the potentially undertorqued casing joint is close to the underlying ZeZ1H formation, a potential risk exists that, in case the joint would leak, injected water might flow behind the liner and expose the ZeZ1H salt. This risk is considered to be small because the cement bond across the ZeZ1H is good (Attachment 9.6.4) preventing flow past the salt. Because of the good cement bond across the layers above the leak, the risk that the injected water might reach the ZeZ2H, also above the suspected joint, is considered unlikely.

Figure 7 – 3D-calliper image of potentially undertorqued casing joint in TUB 10 at 1827 mAHbdf. The section shown is about 2.5 m long, the segment with a slight diameter increase is about 15 cm long.

Compared to TUB-7 this situation is fundamentally different and has a much lower risk profile. Still, a leak investigation will be carried out in Q1 2015 (when relevant tools are available) by running a PLT/PNDT (noise detection tool) to confirm that water is not leaking-off at the suspected casing joint and to verify presence/absence of flow behind casing.

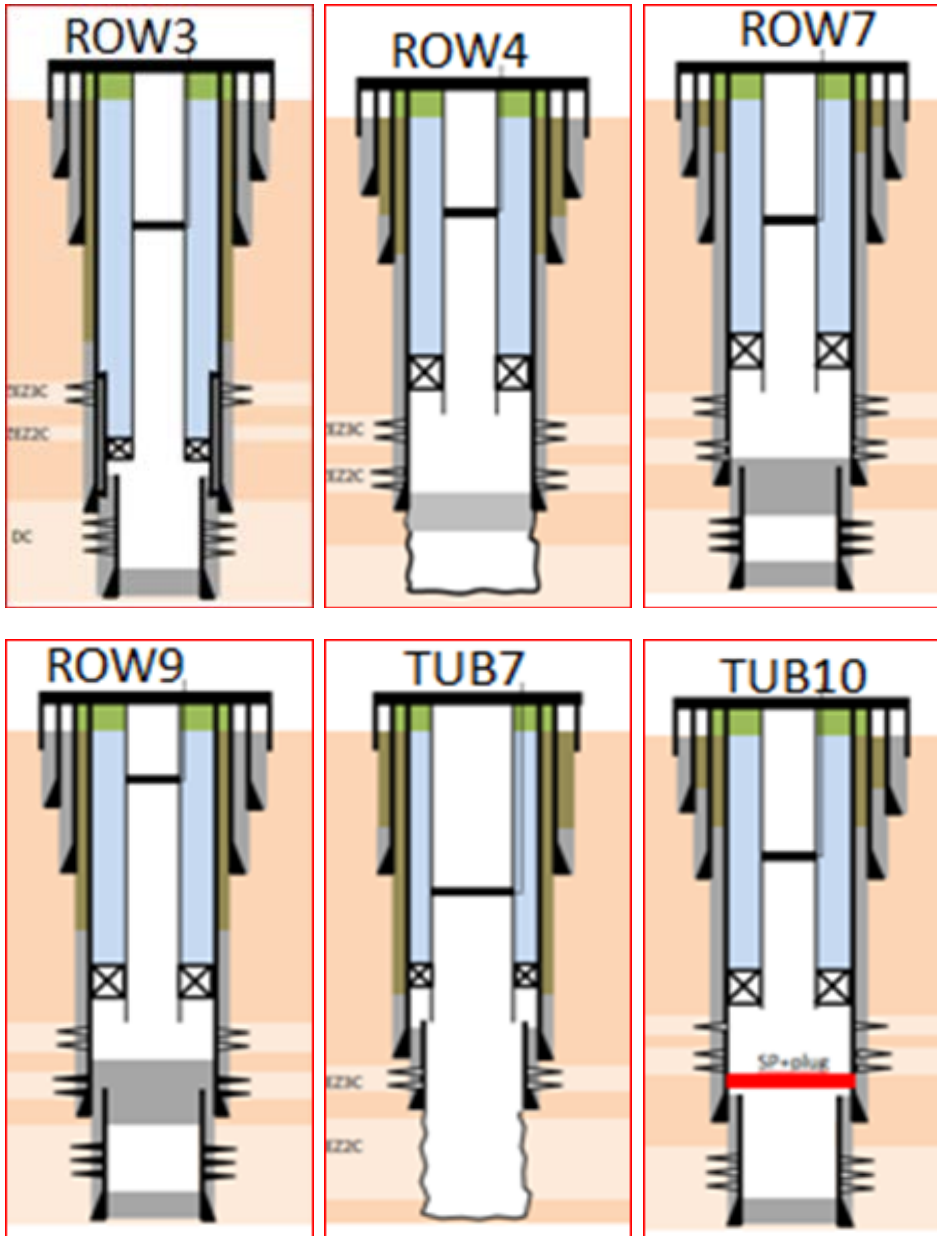
Schematic well diagrams for the evaluated wells are presented in Figure 8. These schematics show that most wells have a cemented and perforated casing across the injection reservoir. Only in TUB7 the injection reservoir has been left open hole. Wells ROW4, ROW7, ROW9 and TUB10 are plugged back.

Figure 8 – Well schematics for the water injection wells (ZeZ2C and ZeZ3C represent the Zechstein reservoirs, whereas DC refers to the Carboniferous sandstone reservoir)

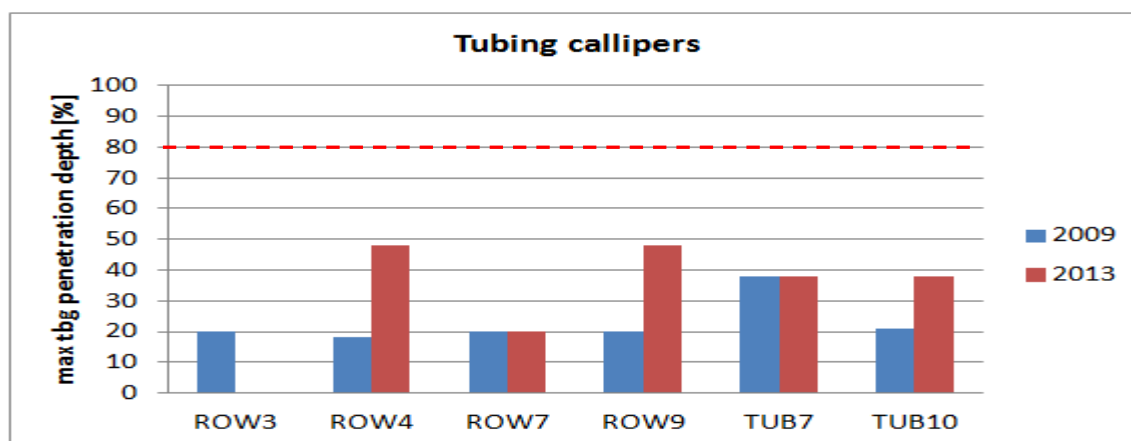
Figure 9 below shows results of callipers taken in the tubing of the water injection wells in 2009, i.e. before start of water injection, and in 2013 3 years after start injection. It shows the maximum pit penetration (as measured in one or two tubing joints) as percentage of the original wall thickness. The results show that the tubing condition has significantly worsened in wells ROW4 and ROW9, whereas it more or less stayed the same in wells ROW7, TUB7 and TUB10. No tubing calliper was carried-out in ROW3 as this well is shut-in until injection is resumed once the pump envelope is appropriate. When water injection will be resumed a new tubing calliper run will be performed.

Figure 9 - Tubing calliper results (max observed pit penetration as % of original wall thickness). The dashed red line indicates the approximate maximum acceptable penetration limit.

The remaining wall thickness and the required wall thickness to withstand the maximum expected pressure difference across the injection tubing are given in Table 8. The calculations show that all tubings still have enough wall thickness even at maximum injection pressure. Still, to secure sufficient injection capacity in the future, workover might be required in ROW4 and ROW9 to either replace the tubing or to protect the current tubing by installing an insert injection string.

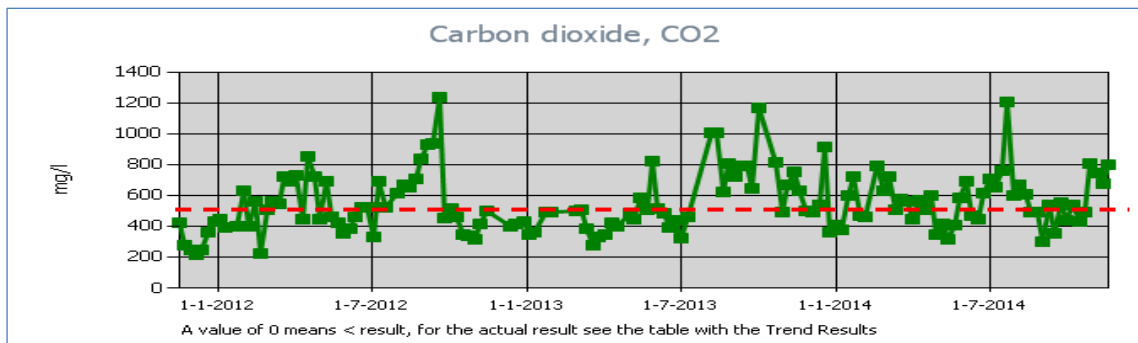
From Figure 11 it can be seen that the CO_2 content in injection water is often above the expected maximum of 500 mg/l. CO_2 originates from the reservoir where the content is even higher than in the disposal water. The CO_2 partitioning between water and gas in the production system depends on the CO_2 concentration in the associated gas, temperature, pressure, pH, and residence time in the production system and is difficult to predict. It must be concluded that the expected maximum was set too low. CO_2 is not included in the EURAL list as it is not harmful in the measured concentrations (reference, sparkling mineral water contains ~5 g/l).

Figure 11 – Carbon dioxide conc. from 2011 until 2014. The dashed red line indicates the expected max. value.

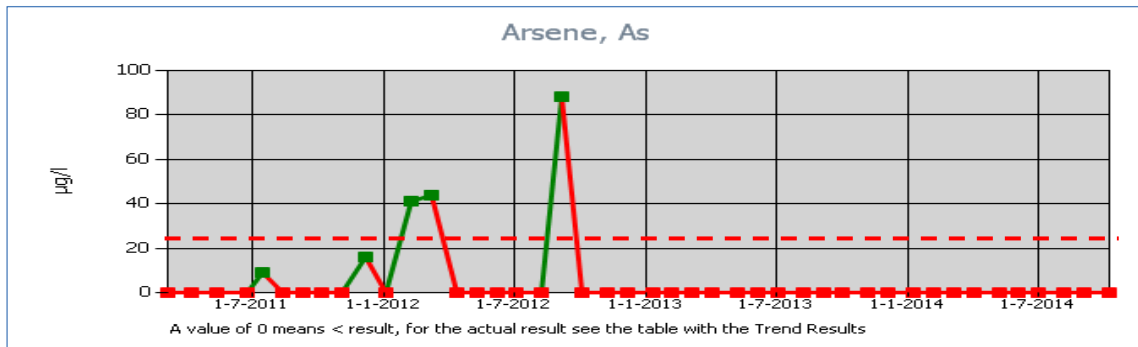
Arsenic is a toxic component of the formation water and is normally present in very low concentrations, below its detection limit of 10 $\mu\text{g/l}$. The maximum expected value is 25 $\mu\text{g/l}$. On 3 occasions a higher concentration was measured (Figure 12). Arsenic may be released when steam comes in contact with isolated minerals in the reservoir that contain Arsenic (such as certain clay minerals). This may explain the sporadic concentrations above the expected maximum. When setting the expected maximum level, such natural mineral bound excursions were not taken into consideration.

Figure 12 - Arsenic concentration from 2011 until 2014. The dashed red line indicates the expected max. value.

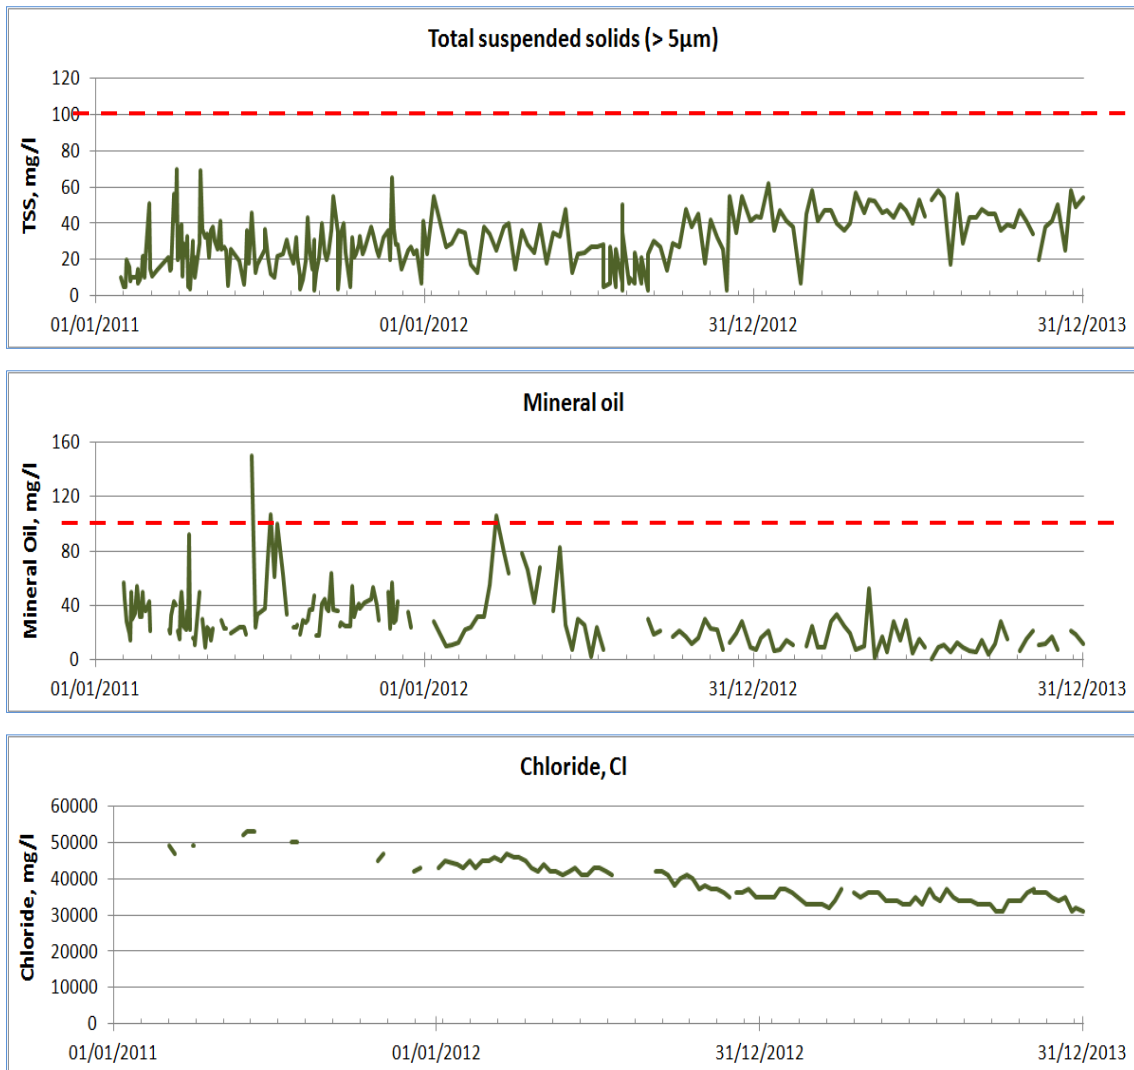
Table 10 also shows that the oil-in-water concentration, measured in samples at the CTF, exceeds the values measured at the Twente injection wells. The oil-in-water concentration, measured during 2013 at the CTF, varied quite a lot with in the range of 0.7-52mg/l (Figure 14). The oil-in-water concentrations in Twente in this same period fall within this bandwidth. A possible cause for the variation could be contaminations observed in the wells: Common practice for all wells is that wireline interventions are preceded by bullheading 30 m³ of hot water to clean the tubing, flushing the oil and solids towards the reservoir. On some occasions, however, retrieved wireline tools were covered with a black pasta of solids and oil/wax containing elevated levels of Fe, FeO, S, Ca, Si and CaCO₃. This suggests that some wells were so dirty that the clean-out was not sufficiently effective and that some of these contaminants could have been back produced. Overall however, the data indicate that that the oil-in-water quality is within allowed limits.

Figure 14 – Suspended solids, oil-in-water and chloride concentrations measured in the injection water at the CTF. The dashed red line indicates the expected max. value. Note that there is no limit for the chloride concentration.

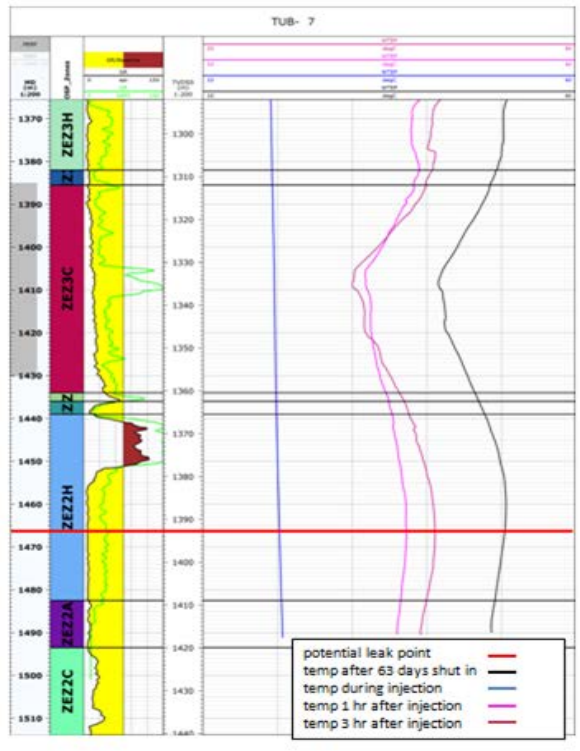
- A cooling effect from regular injection ceased 63 days before logging is still visible over 3C perforations
- During injection, temperature gauge only sees cold water (blue line)
- 1 hr after injection well warming is noticed from geothermal heat influx.
- 3 hr after injection this effect becomes more apparent, differences at different parts of the well bore as well. The overall temperature log seems to approach 'normal' shut in conditions again.
- No sign of any water injection at potential leak point becomes apparent.

Figure 19 – Temperature logging results
